AFWAL-TR-84-2048

DAMAGE CAUSED TO POLYURETHANE FOAMS BY AGING,
SIMULATED SUNLIGHT EXPOSURE, HEAT AND FIRE

Leo Parts
MONSANTO RESEARCH CORPORATION
DAYTON LABORATORY
1515 NICHOLAS RD.
DAYTON, OHIO 45407

JULY 1984

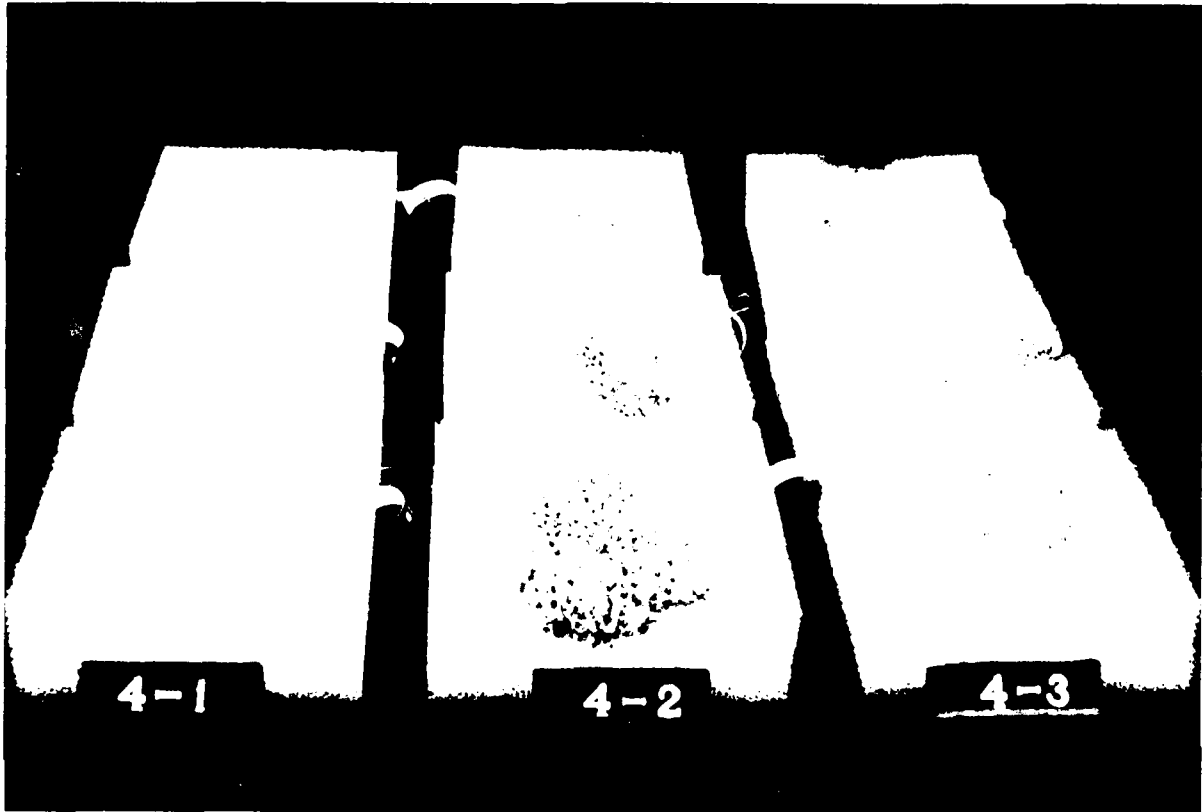
Figure A1-135. Perspective view of yellow foam specimens, subjected to sustained burning. Samples ignited by flame from top while in horizontal position, and from bottom while in vertical and horizontal positions, respectively.

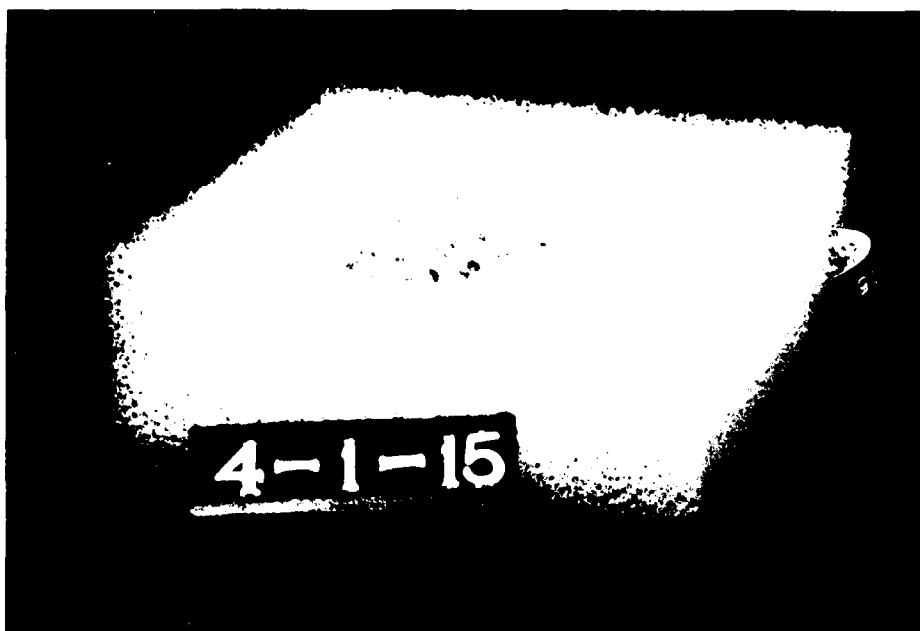
Figure A1-136. Sample 4-1-15, perspective view.

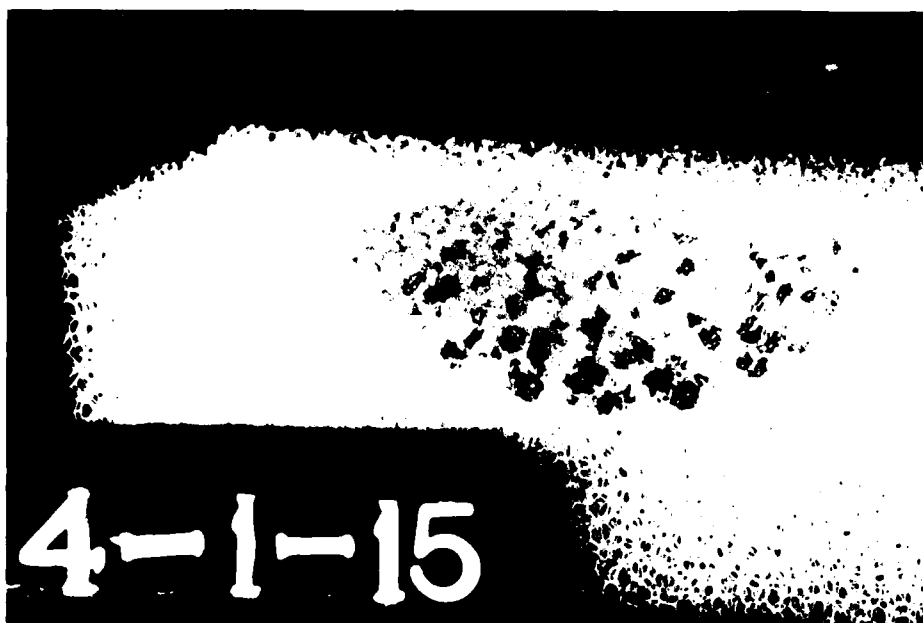
Figure A1-137. Sample 4-1-15, cross-sectional view.

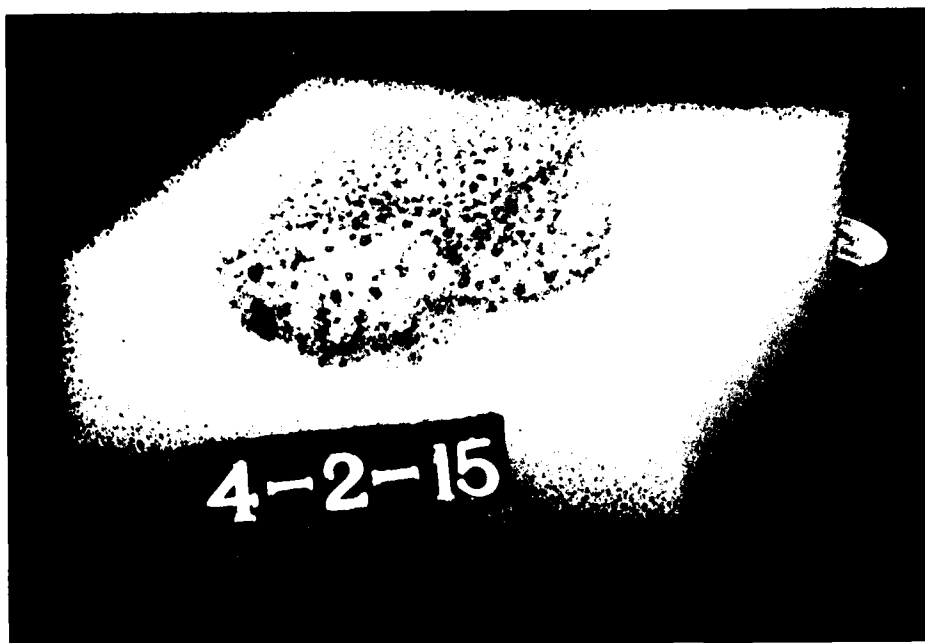
Figure A1-138. Sample 4-2-15, perspective view.

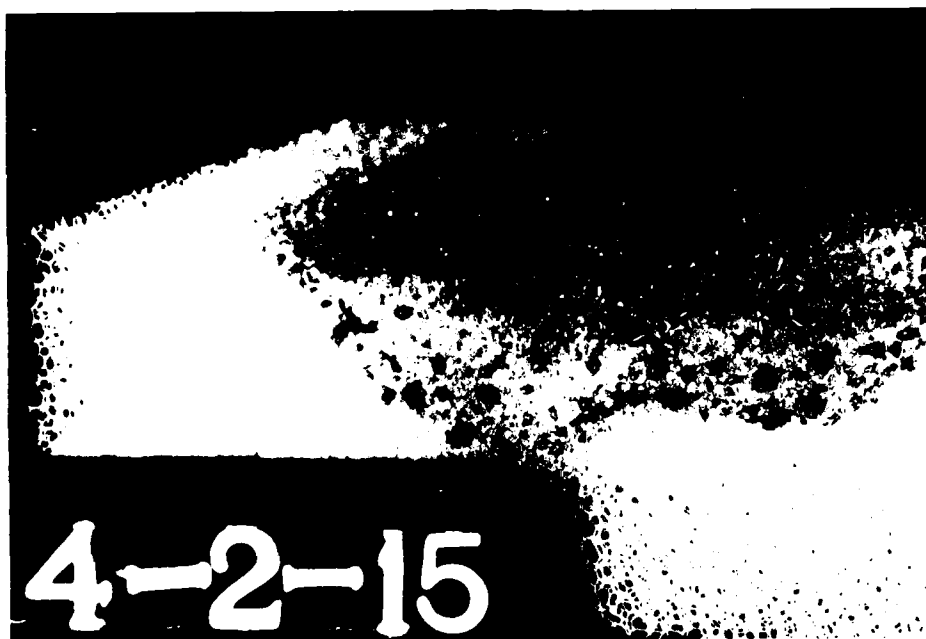
Figure A1-139. Sample 4-2-15, cross-sectional view.

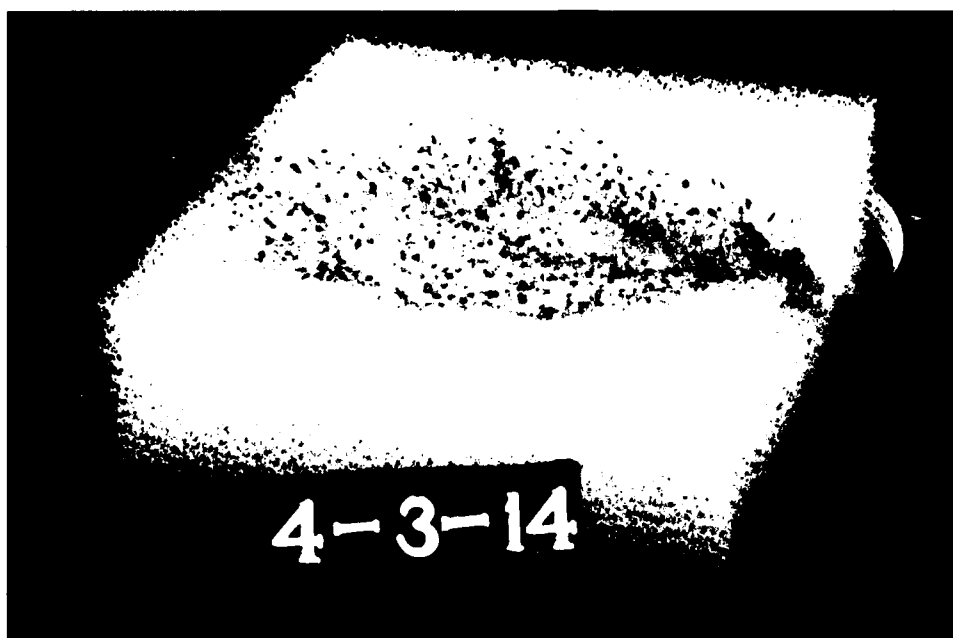
Figure A1-140. Sample 4-3-14, cross-sectional view.

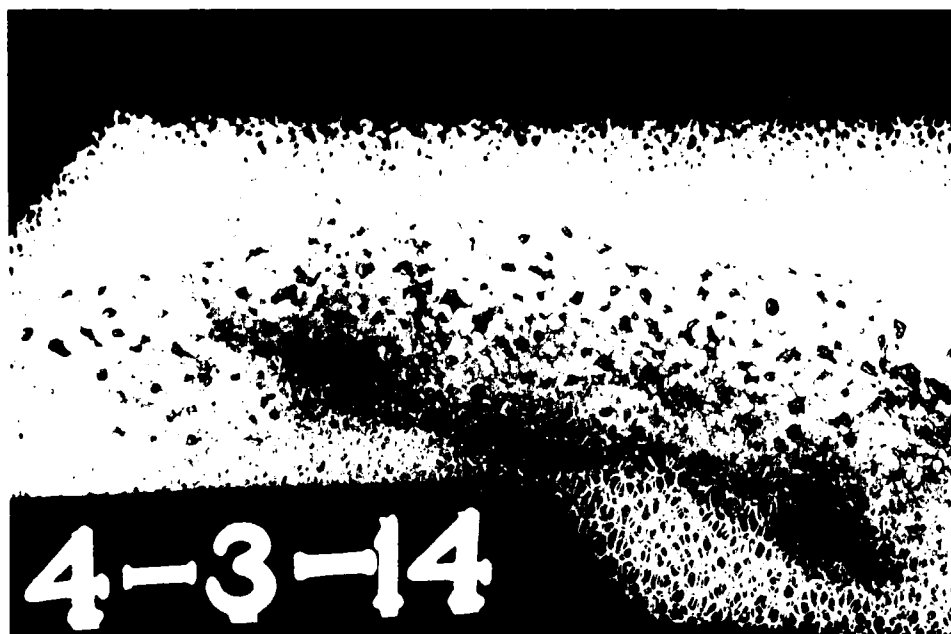
Figure A1-141. Sample 4-3-14, perspective view.

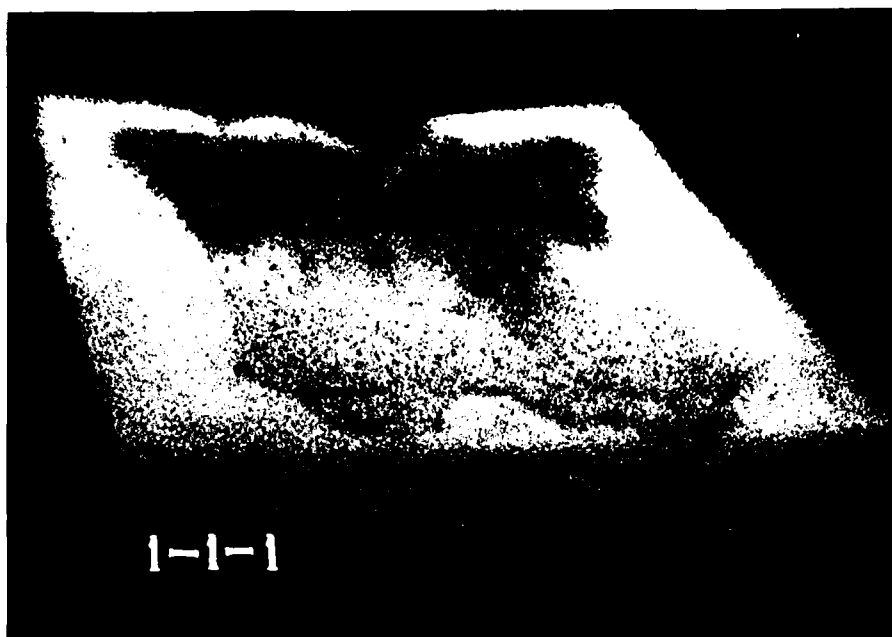
Figure A1-144. Sample 1-1-1, perspective front view.

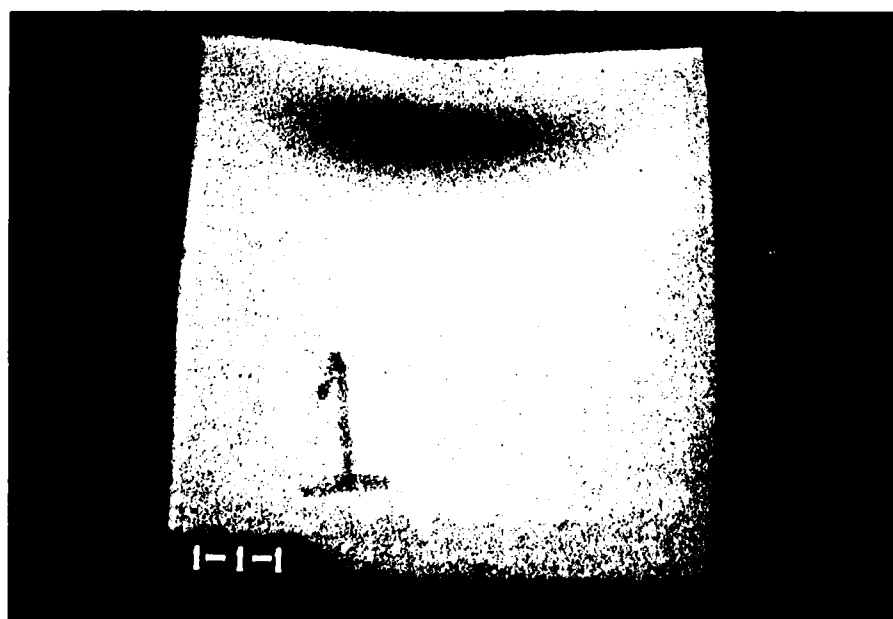
Figure A1-147. Sample 1-1-1, direct rear view.

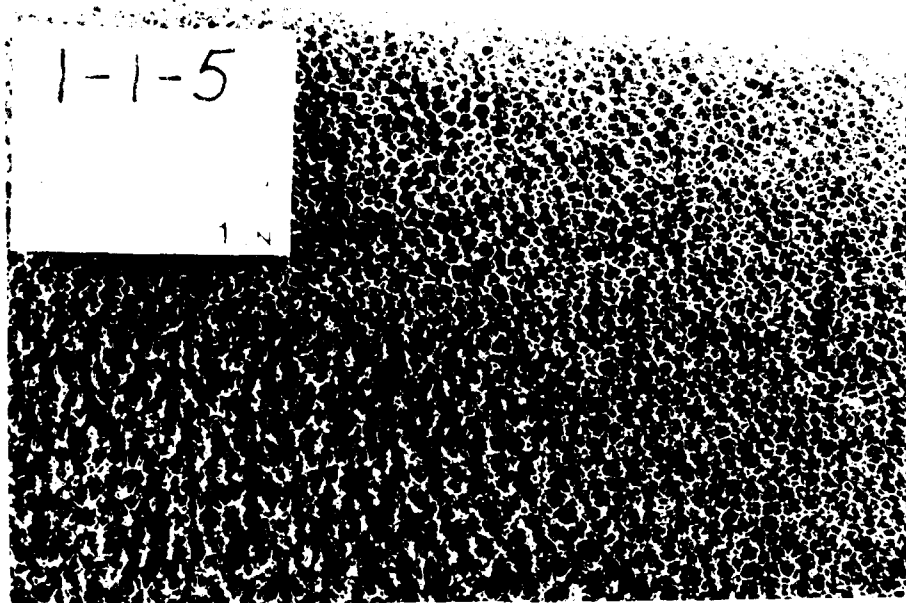
Figure A1-156. Sample 1-1-5, close-up view of front surface.

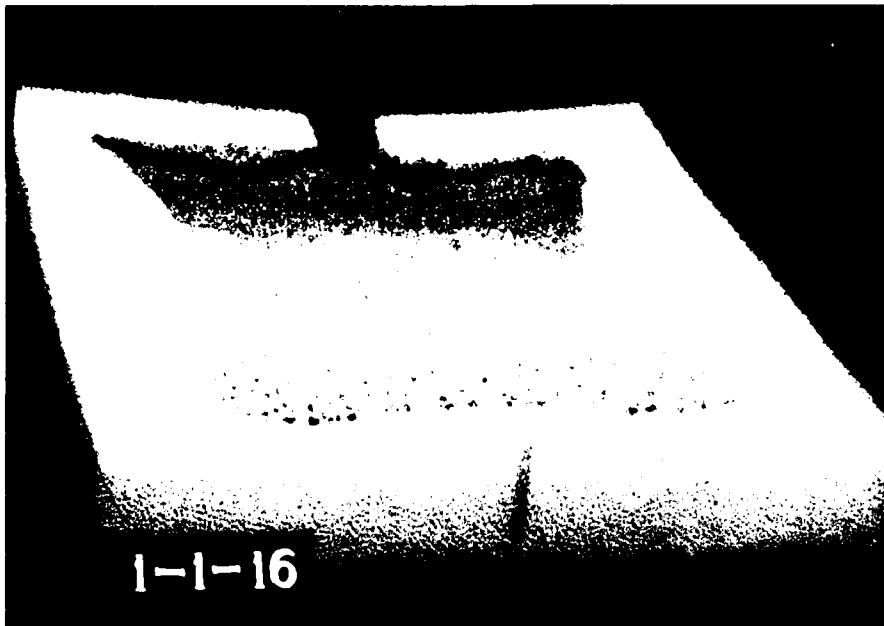
Figure A1-187. Sample 1-1-16, perspective front view.

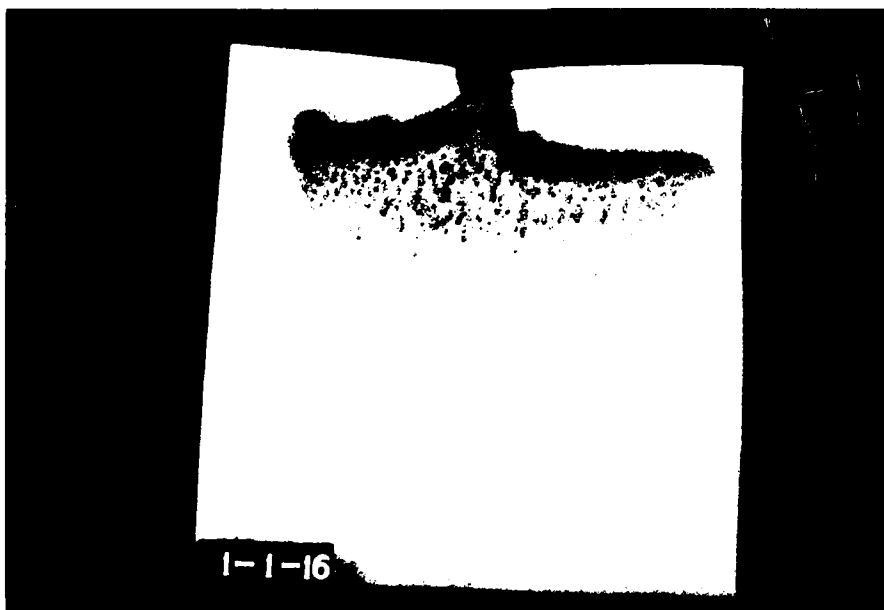
Figure A1-188. Sample 1-1-16, direct front view.

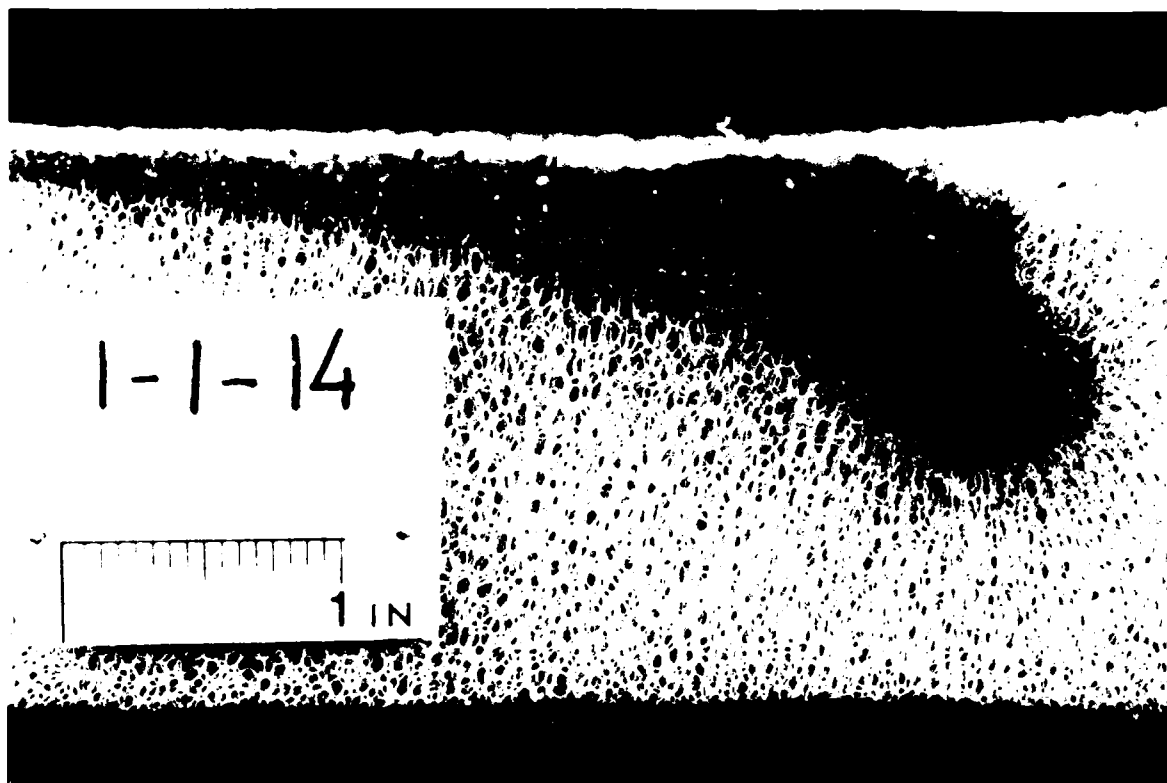
Figure A1-186. Sample 1-1-14, close-up cross-sectional view, upper left quadrant.

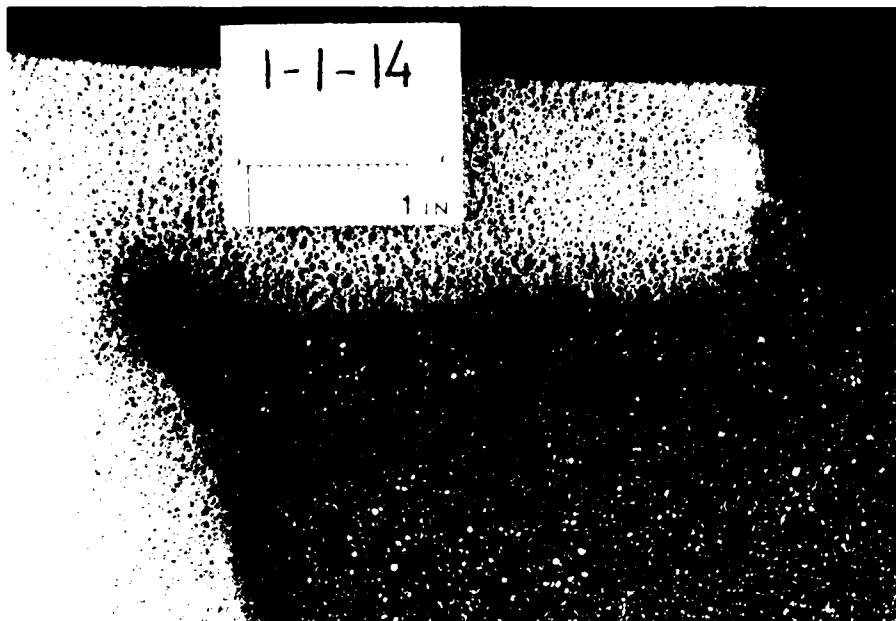
Figure A1-184. Sample 1-1-14, close-up front view, upper left quadrant.

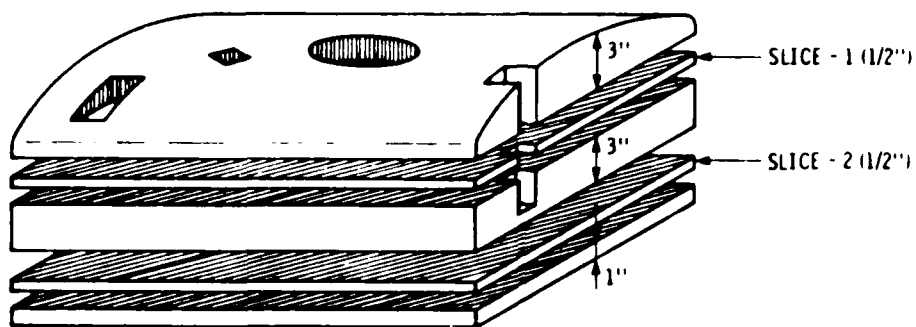
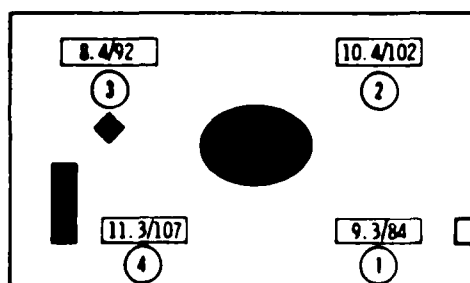
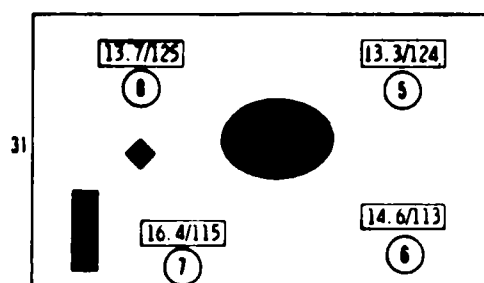
Figure A2-3. Sample locations, F-4 (brown-stained) foam.

Samples were cut, as shown in Figure A2-3, and sent to SCOTFOAM Corporation and Union Carbide Corporation for analysis, to determine the source of the discoloration. From visual observations, this foam appeared to have experienced degradation. Therefore, physical properties of this foam were also determined. The results were compared with data for the blue foam used in the qualification tests (Ref. A2-2), that was also from Run W 9572. The difference in tensile strength between Slice 1 and Slice 2 (see Table A2-1) was at least partly due to pore size. From visual observation, Slice 1 had about 10 pores per inch (ppi) and Slice 2 had about 14 ppi. The overall average tensile strength of the brown-stained foam was about 20% lower than the average for the original foam (see Table A2-1). This decrease probably resulted from foam aging.

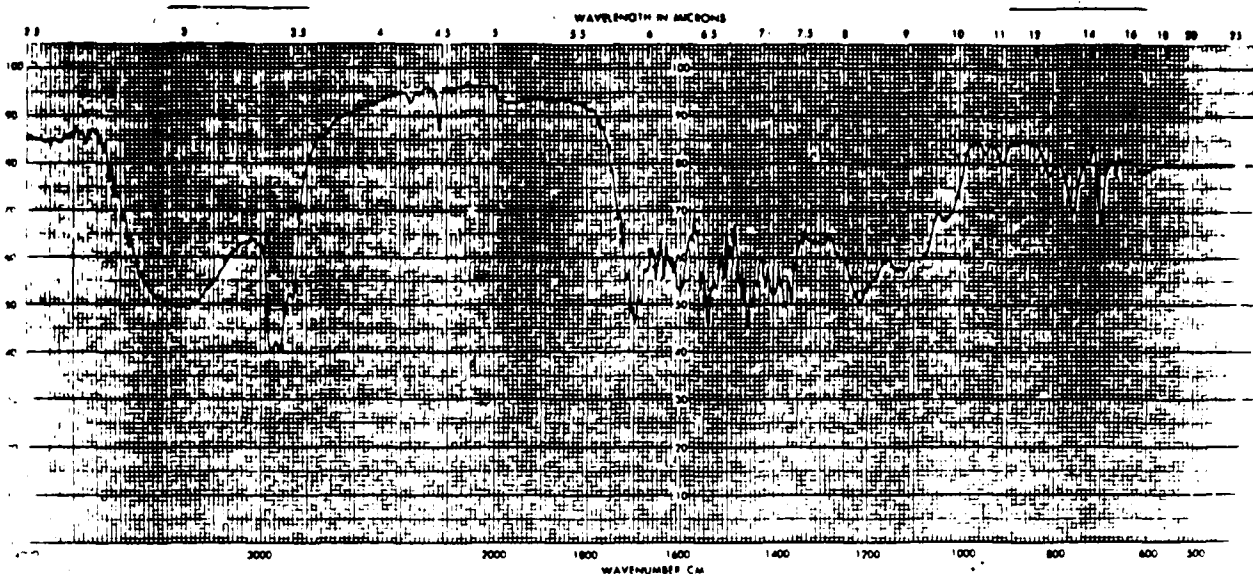
Figure A2-4. Infrared spectrum of acetone extract from F-4 (brown-stained) foam.

Extraction tests were conducted on the F-4 foam and on new foam. Soxhlet extraction with perchloroethylene removed the blue color from both samples (see Table A2-2). With acetone, some of the brown stain was removed from the F-4 foam. Its color became bluish-green, whereas the fresh foam did not change color upon extraction with acetone. Elemental analysis of this extract (after removal of acetone) showed differences in carbon, hydrogen and oxygen content, compared to an acetone extract from the fresh blue foam (see Table A2-3). Infrared spectra of the acetone extracts also showed some differences in relative peak intensities (see Figures A2-4 and A2-5, and Table A2-4. Ultraviolet spectra were also determined on the acetone extracts, no differences were observed (see Figure A2-6).

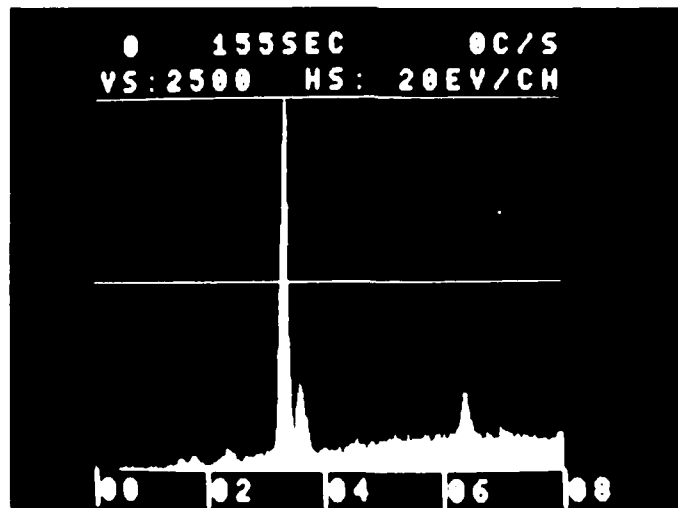
Figure A7-4. EDXA spectra of deposit on filter.

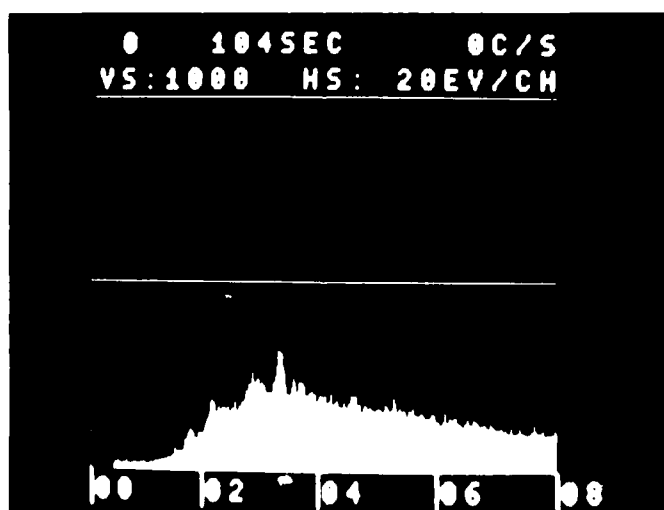
Figure A7-6. EDXA of control.

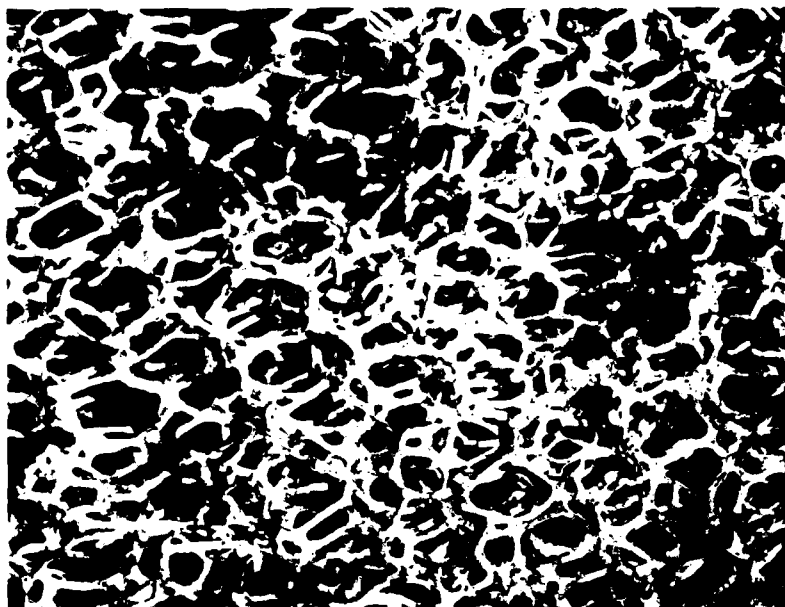
Figure A7-7. Light microscope photograph of deposit (white areas) 50X.

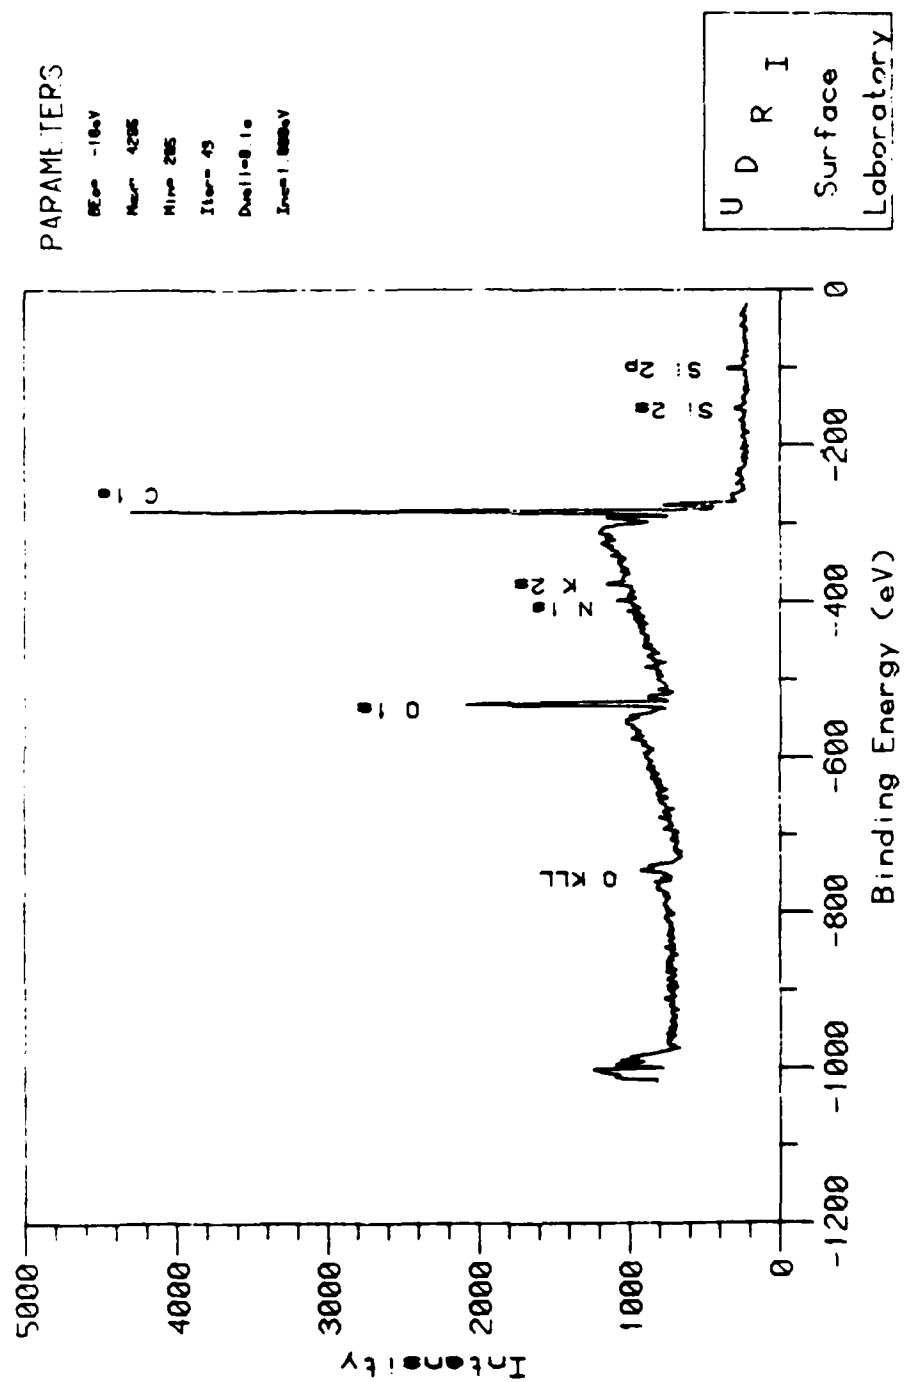
Figure A7-8. Low resolution XPS scan.

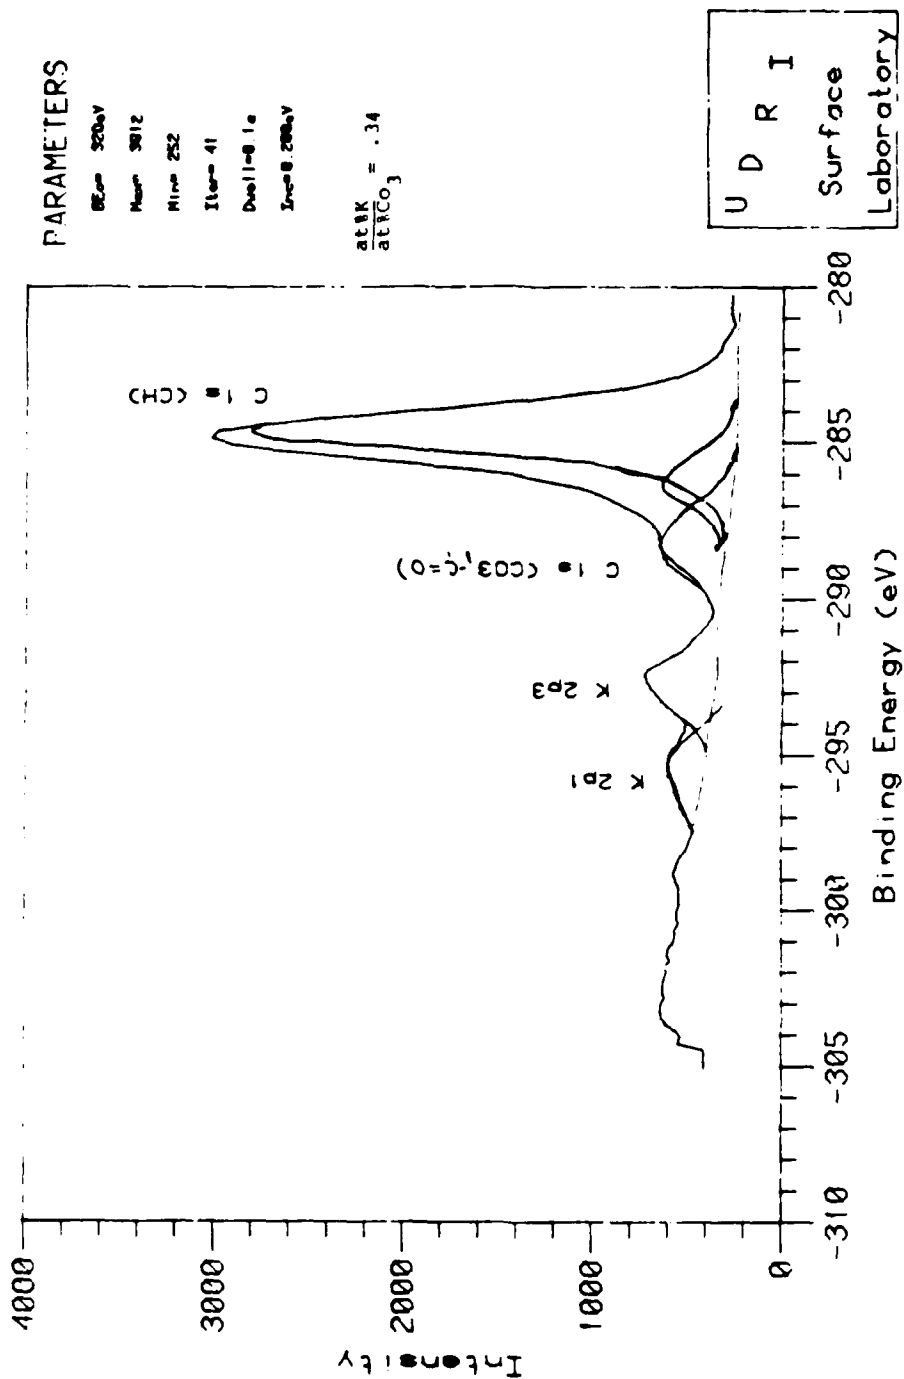
Figure A7-3. High resolution XPS scan.
